STUDY ON THE SURFACE INFILTRATION RATE OF PERMEABLE PAVEMENTS

May 26, 2004

Prepared for:
Interlocking Concrete Pavement Institute

By: Eban Z. Bean, Engineering Intern
William F. Hunt, Ph.D., PE
David A. Bidelsbach, Engineering Intern
Jonathan T. Smith, PE

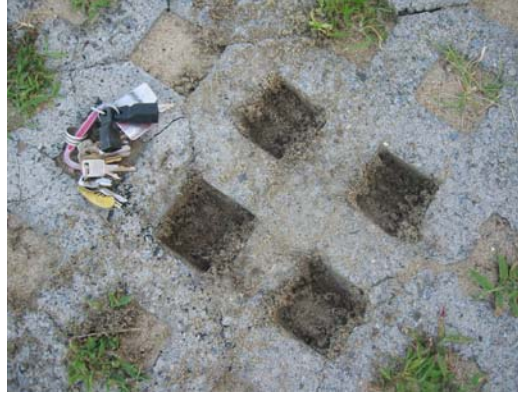
Figure 8. Maintained site at site 16. Note the depth of soil removed from the gaps.

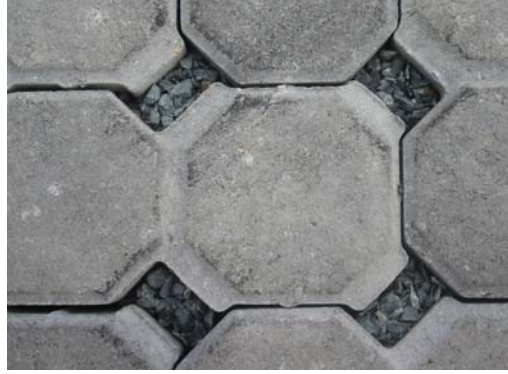
Figure 11. PICP at site 3 in Ocean City, MD. This pea gravel is visually free of fines.

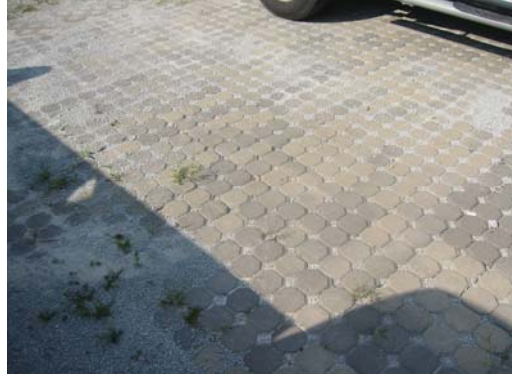
Figure 12. Site 10 PICP parking area with fines visible in the lower left hand corner.

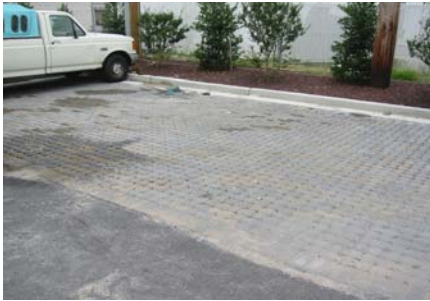
Site 1: Captiva Bay Condos
Type of Surface: Permeable Interlocking Concrete Pavements
Use: Residential Parking

Size (stalls/sq. ft.): 3,360 sq. ft.
Approximate Drainage Area: Equal to permeable area
Construction Date: 2003
Address: 85th St., Ocean City, MD
Test Date: July 29, 2003
Visual Assessment: Condos under construction w/ hay bales around test site.
Maintenance Practice: New

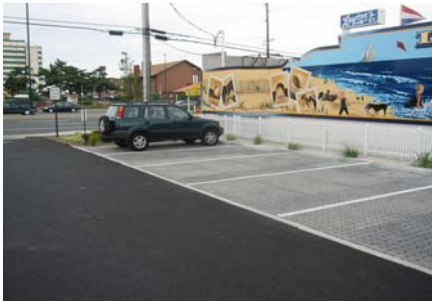
Site 2: CVS Pharmacy
Type of Surface: Permeable Interlocking Concrete Pavements
Use: Fringe parking

Size (stalls/sq. ft.): 5,760 sq. ft.
Approximate Drainage Area: Equal to permeable area.
Construction Date: 2003
Address: 12001 Ocean Highway, Ocean City, MD
Test Date: July 29, 2003
Visual Assessment: Looks clean working well.
Maintenance Practice: New

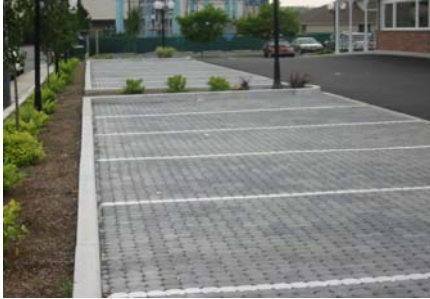
Site 3: Dough Roller's
 Type of Surface: Permeable Interlocking Concrete Pavements
 Use: Resteraunt parking

Size (stalls/sq. ft.): 6,000 sq. ft.
 Approximate Drainage Area: 8,500 sq. ft.
 Construction Date: 2003
 Address: 41st St. & Coastal Highway, Ocean City, MD
 Test Date: July 29, 2003
 Visual Assessment: Clean and open pores.
 Maintenance Practice: New Site

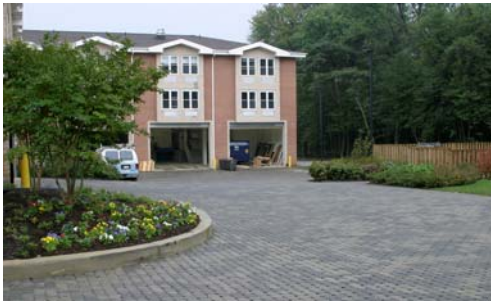
Site 4: Baywoods of Annapolis Assisted Living Center
Type of Surface: Permeable Interlocking Concrete Pavements
Use: Parking and drive areas of assisted living center

Size (stalls/sq. ft.): 14,000 sf.
Approximate Drainage Area: Permeable area
Construction Date: 2002
Address: Bembe Beach Rd, Annapolis, MD
Test Date: July 28, 2003
Visual Assessment: Looks as though voids are permeable.
Maintenance Practice: None

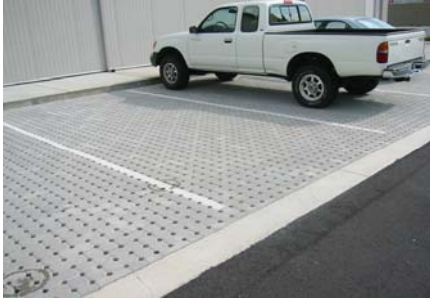
Site 5: Mickey's Pastry Shop
 Type of Surface: Permeable Interlocking Concrete Pavements
 Use: Public parking for bakery

Size (stalls/sq. ft.): 30
 Approximate Drainage Area: Equal
 Construction Date: 2001
 Address: 2704 Graves Dr., Goldsboro, NC
 Test Date: July 22, 2003
 Visual Assessment: Looks very clean with minimal debris in voids.
 Maintenance Practice: None

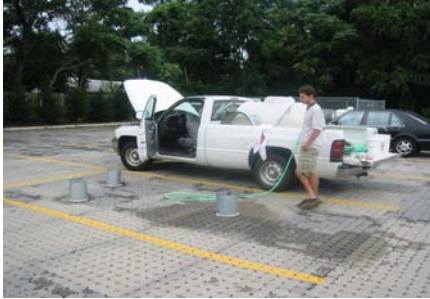
Site 6: Wal-Mart
 Type of Surface: Permeable Interlocking Concrete Pavements
 Use: Overflow parking

Size (stalls/sq. ft.): 43,000 sq.ft.
 Approximate Drainage Area: Permeable area.
 Construction Date: Summer 2001
 Address: 4493 Highway One, Rehoboth Beach, DE
 Test Date: July 29, 2003
 Visual Assessment: Lot is rarely used. May have underdrain.
 Maintenance Practice: New

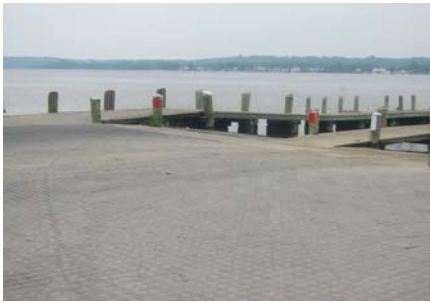
Site 8: Boat Ramp
Type of Surface: Permeable Interlocking Concrete Pavements
Use: Parking for boat launching.

Size (stalls/sq. ft.): 22,000 sq. ft.
Approximate Drainage Area: Equal to permeable area.
Construction Date: 2001
Address: Route 231, Prince Frederick, MD
Test Date: July 28, 2003
Visual Assessment: Heavily used with lots of sand in void spaces.
Maintenance Practice: none

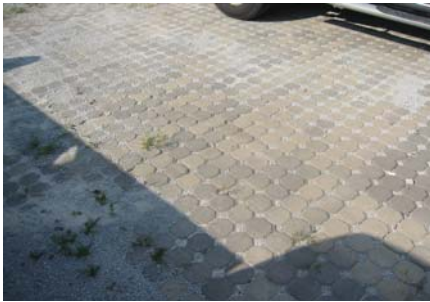
Site 10: River Bend
 Type of Surface: Permeable Interlocking Concrete Pavements
 Use: Parking for public works buildings

Size (stalls/sq. ft.): 8 stalls
 Approximate Drainage Area: Equal to permeable area.
 Construction Date: Dec. 2000
 Address: 45 Shoreline Dr., River Bend, NC
 Test Date: July 22, 2003
 Visual Assessment: Compacted fines from gravel drive in voids.
 Maintenance Practice: None

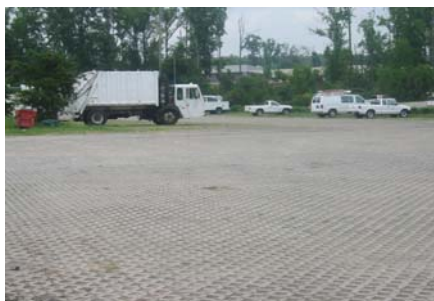
Size (stalls/sq. ft.): 0.75 acre
 Approximate Drainage Area: 1 acre
 Construction Date: 1995
 Address: 400 James Jackson Rd., Cary, NC
 Test Date: August 7, 2003
 Visual Assessment: Small plants, sand, and trash in void spaces, slightly sloped.
 Maintenance Practice: None, only replaced broken blocks
