STUDY ON THE SURFACE INFILTRATION RATE OF PERMEABLE PAVEMENTS

May 26, 2004

Prepared for:
Interlocking Concrete Pavement Institute

By: Eban Z. Bean, Engineering Intern
William F. Hunt, Ph.D., PE
David A. Bidelsbach, Engineering Intern
Jonathan T. Smith, PE

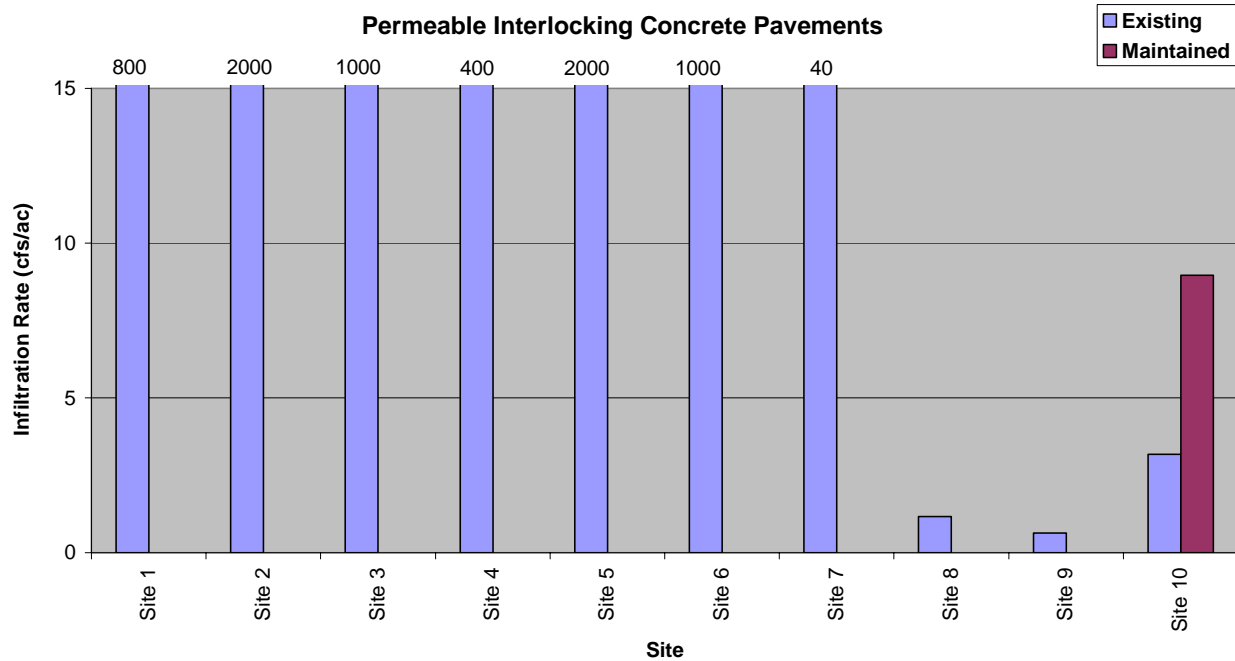
Figure 13. Surface infiltration rates for PICP or similar applications.

Ten PICP sites were tested; seven in Maryland, two in North Carolina and one in Delaware. Six of these sites were tested using the surface inundation test, due to their high surface infiltration rates (>60 cfs/ac, >2.8 m³/s-ha). Site 7 maintained hydraulic head just enough to fill the double ring infiltrometer rings for testing, but had a surface infiltration rate average of 40 cfs/ac (2 m³/s-ha). The three remaining PICP sites had surface infiltration rates low enough so that a double-ring infiltrometer test was performed. These same three PICP sites were located in close proximity to areas containing exposed fine soil particles, i.e. gravel drive, a river bed, and a beach. It should be noted that maintenance was preliminarily performed on site 10 with anticipation of obtaining enough sites in the future to be able to compare maintained and unmaintained conditions for PICP sites. However, not enough sites were found to be able to test for maintenance and therefore other lower infiltrating sites were not tested. Figure 13 shows estimated surface infiltration rates for permeable pavement applications using PICP or similar products. The last three surface infiltration rates are the three PICP sites located in close proximity to exposed fine soil particles.

Surface infiltration rates of PICP filled with gravel are not limited by their surface infiltration capacity, provided they are sited in areas free of soil disturbances. The average PICP surface infiltration rate was 900 cfs/ac ($40 \text{ m}^3/\text{s-ha}$), while the PICP sites near disturbed soils with fines was 1.6 cfs/ac ($0.078 \text{ m}^3/\text{s-ha}$), a decrease of over 99%.

- 1) PICP lots installed for infiltration purposes should not be sited adjacent to areas with free fine particles. Fine particles have been shown to severely decrease surface infiltration rates.
- 2) Maintenance should include the use of a vacuum sweeper at least once per year. More frequent maintenance should be practiced if accumulation of fines is evident from foot traffic, automotive traffic, or any other means. Problems with fines should be addressed before the fines are either compacted into void spaces or migrate to lower, harder to maintain depths within the profile.

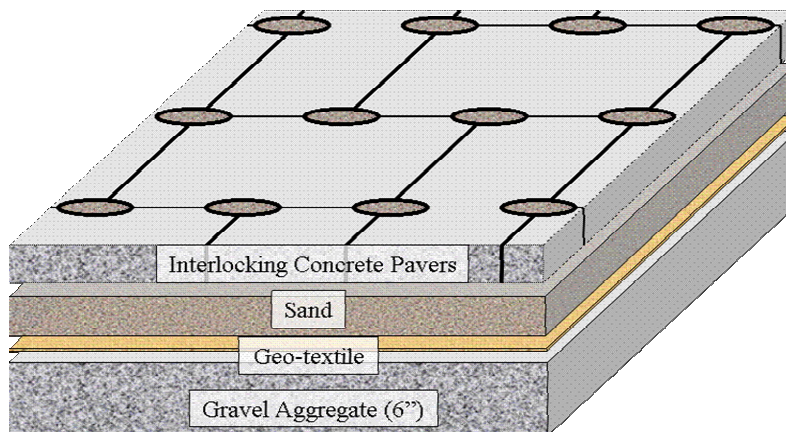
Size (stalls/sq. ft.): 22,000 sq. ft.
Approximate Drainage Area: Equal to permeable area.
Construction Date: 2001
Address: Route 231, Prince Frederick, MD
Test Date: July 28, 2003
Visual Assessment: Heavily used with lots of sand in void spaces.
Maintenance Practice: none

Run #1	Run #2	Run #3	Average
1.72	0.79	0.97	1.16

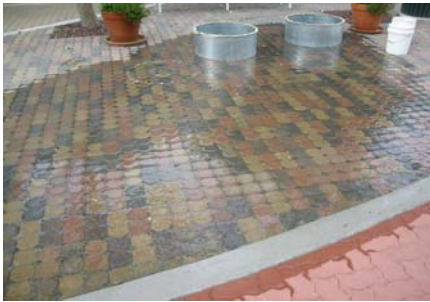
Visual Assessment: Lots of sand in voids.

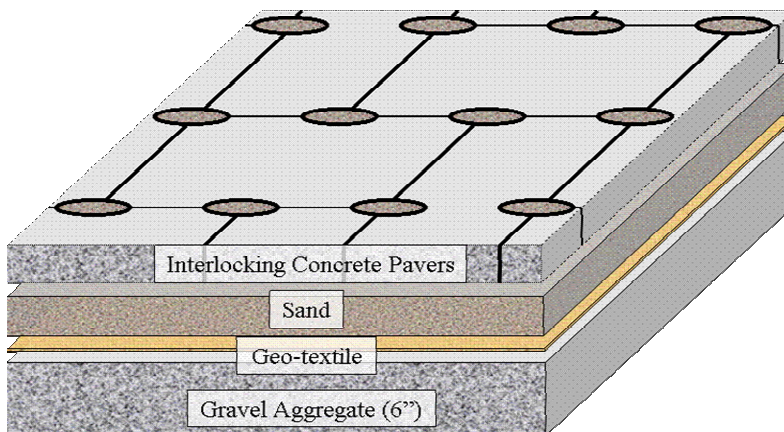
Size (stalls/sq. ft.): 8 stalls
 Approximate Drainage Area: Equal to permeable area.
 Construction Date: Dec. 2000
 Address: 45 Shoreline Dr., River Bend, NC
 Test Date: July 22, 2003
 Visual Assessment: Compacted fines from gravel drive in voids.
 Maintenance Practice: None

Existing Conditions Test (cfs/ac):			
Run #1	Run #2	Run #3	Average
1.38	1.32	6.82	3.18
Post-Maintenance Condition Test (cfs/ac):			
8.25	15.48	3.17	8.96

Maintenance Performed: Removed top 0.75" of material from drainage pores.

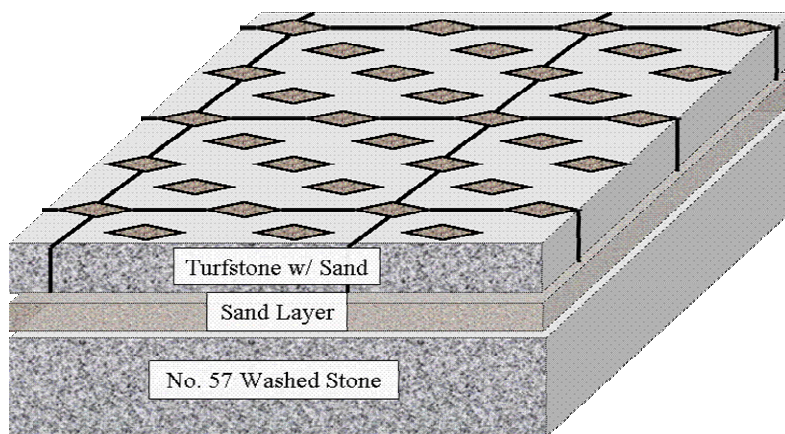
Size (stalls/sq. ft.): 0.75 acre
 Approximate Drainage Area: 1 acre
 Construction Date: 1995
 Address: 400 James Jackson Rd., Cary, NC
 Test Date: August 7, 2003
 Visual Assessment: Small plants, sand, and trash in void spaces, slightly sloped.
 Maintenance Practice: None, only replaced broken blocks

Existing Conditions Test (cfs/ac):			
Run #1	Run #2	Run #3	Average
0.30	0.27	0.60	0.39
Post-Maintenance Condition Test (cfs/ac):			
0.60	0.75	0.56	0.64

Maintenance Performed: Removed top 0.5" of material from drainage pores.

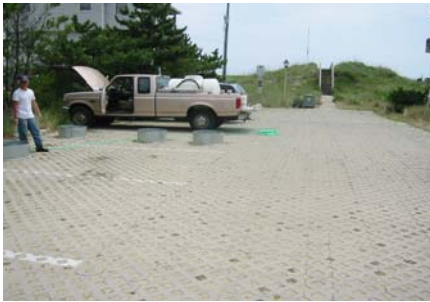
Visual Assessment: Grass in 30% of voids, very sandy and has pine trees.

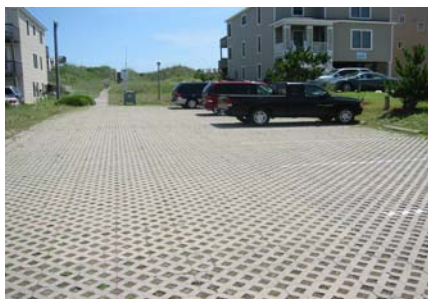
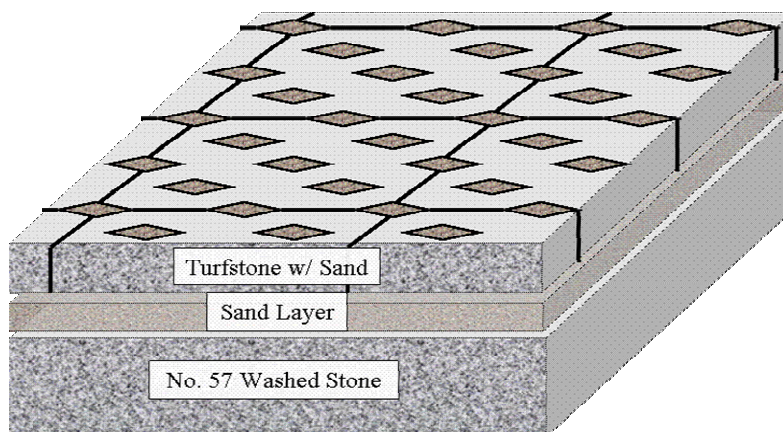
Appendix C13

Site 13: Gull Beach Access
 Type of Surface: Concrete Grid Pavers
 Use: Beach Access Parking

Size (stalls/sq. ft.): 12 stalls
 Approximate Drainage Area: Additional 50' towards the beach.
 Construction Date: 1985
 Address: S. Virginia Dare Trail and Gull St., Nags Head, NC
 Test Date: July 15, 2003
 Visual Assessment: Sand in voids and some grass.
 Maintenance Practice: As needed after large storms (a few times per year).

Existing Conditions Test (cfs/ac):			
Run #1	Run #2	Run #3	Average
0.97	1.58	3.52	2.02
Post-Maintenance Condition Test (cfs/ac):			
2.17	2.97	3.60	2.91

Maintenance Performed: Removed top 0.75" of material from drainage pores.

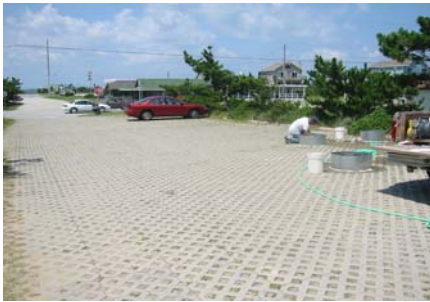
Type of Surface: Concrete Grid Pavers

Use: Beach Access Parking

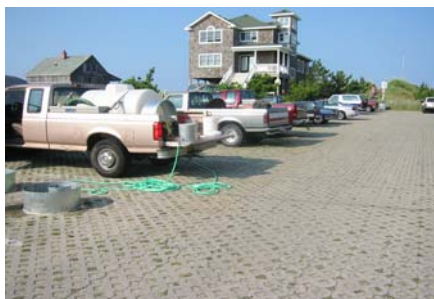
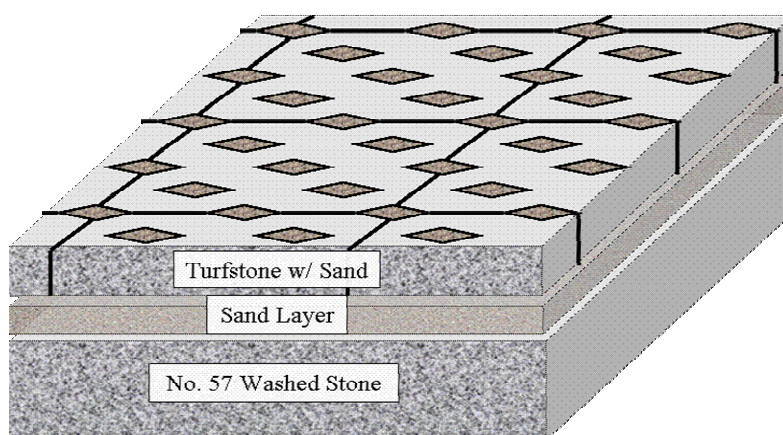
Visual Assessment: Very sandy with grass in 30% of voids.

Run #1	Run #2	Run #3	Average
1.58	1.07	2.32	1.66

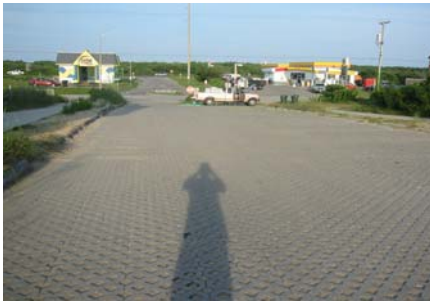
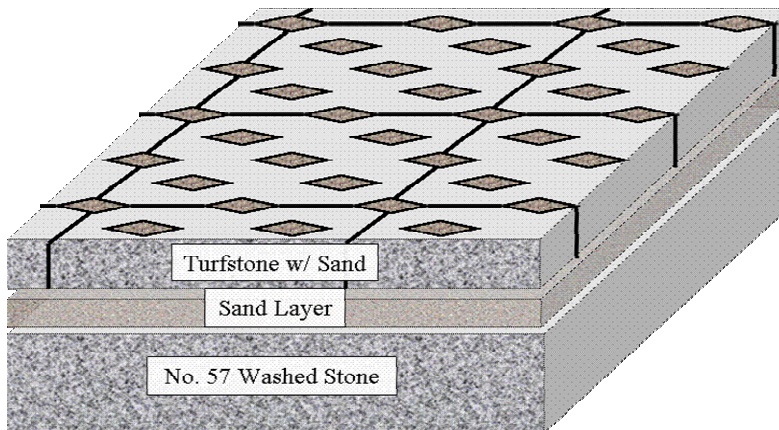
Appendix C16

Site 16: Conch Beach Access
 Type of Surface: Concrete Grid Pavers
 Use: Beach Access Parking

Size (stalls/sq. ft.): 8200 sq. ft. 20 stalls
 Approximate Drainage Area: 9400 sq. ft.
 Construction Date: 1984
 Address: S. Virginia Dare Tr. & Conch St., Nags Head, NC
 Test Date: July 16, 2003
 Visual Assessment: Very loose sand.
 Maintenance Practice: As needed after large storms (a few times per year).

Existing Conditions Test (cfs/ac):			
Run #1	Run #2	Run #3	Average
2.98	6.26	1.68	3.64
Post-Maintenance Condition Test (cfs/ac):			
2.48	3.47	5.93	3.96

Maintenance Performed: Removed top 0.5" of material from drainage pores.

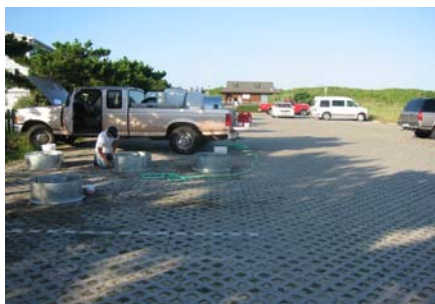
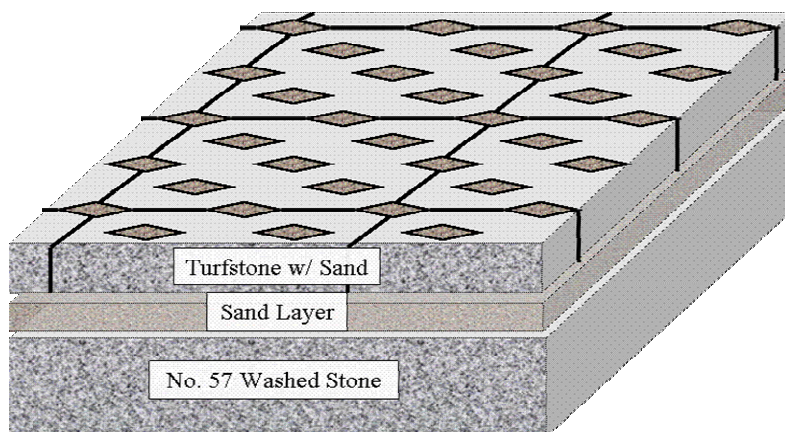
Visual Assessment: Sand and some small grass plants in void spaces.

Run #1	Run #2	Run #3	Average
0.44	3.57	1.01	1.67

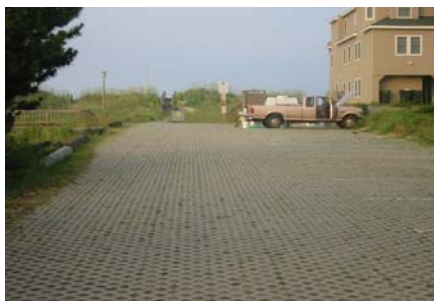
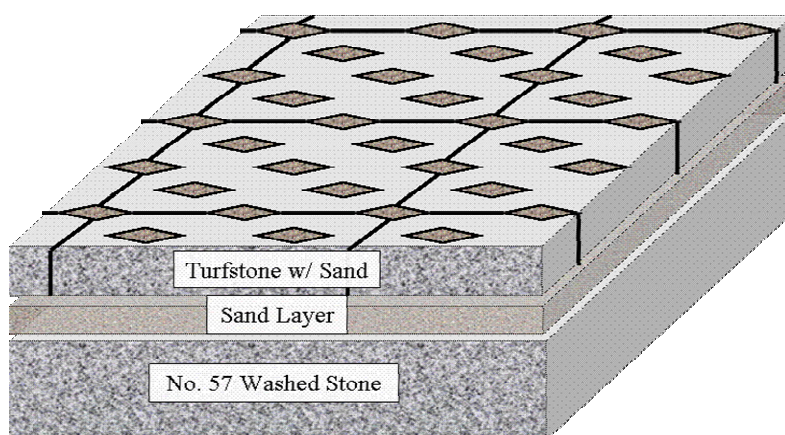
Visual Assessment: Grass coverage varies from 20-70% and noticeable oil spots.

Run #1	Run #2	Run #3	Average
1.62	1.70	2.20	1.84

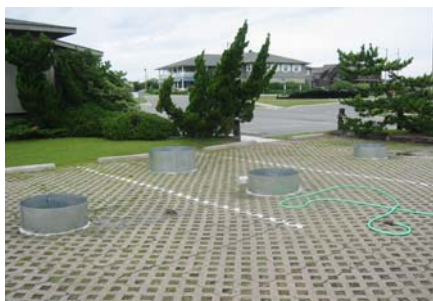
Existing Conditions Test (cfs/ac):			
Run #1	Run #2	Run #3	Average
3.43	3.53	2.50	3.15
Post-Maintenance Condition Test (cfs/ac):			
22.82	2.82	6.00	10.56

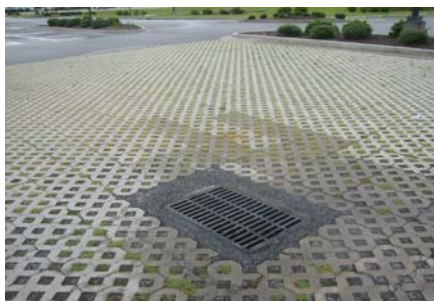
Existing Conditions Test (cfs/ac):			
Run #1	Run #2	Run #3	Average
2.44	1.41	2.03	1.96
Post-Maintenance Condition Test (cfs/ac):			
3.65	2.33	2.91	2.96

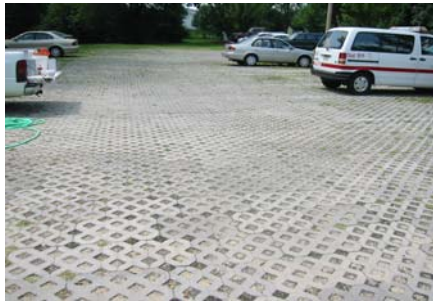
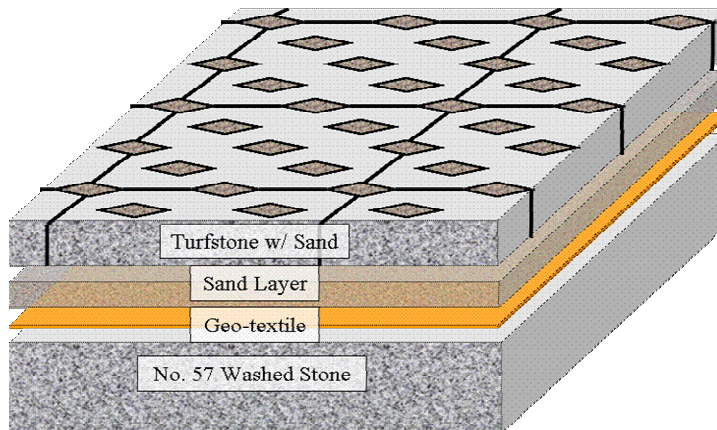
Appendix C23

Site 23: Kinston TS
 Type of Surface: Concrete Grid Pavers
 Use: Police vehicle parking

Size (stalls/sq. ft.): 6300 sq. ft. 20 stalls
 Approximate Drainage Area: 6300 sq. ft.
 Construction Date: Summer 1999
 Address: 207 E. King St., Kinston, NC
 Test Date: July 21, 2003
 Visual Assessment: Very sandy with less than 10% grass in void spaces.
 Maintenance Practice: One sweep per year with a street sweeper.

Run #1	Run #2	Run #3	Average
33.14	12.67	22.74	22.85

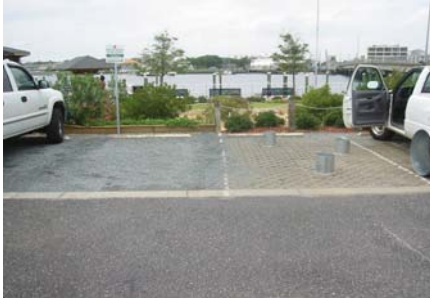
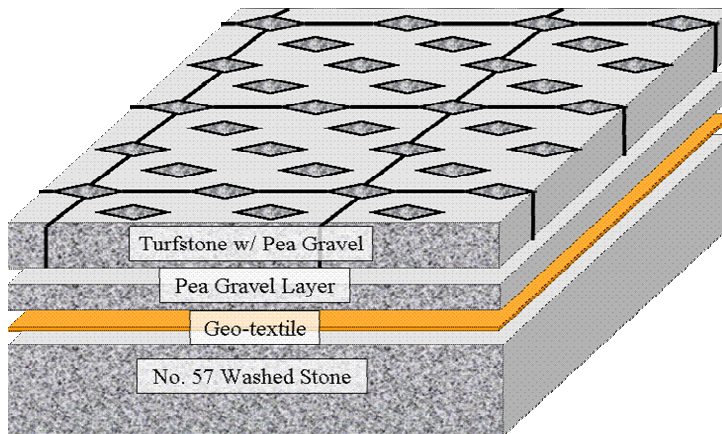
Appendix C24

Site 24: Wynn Plaza
 Type of Surface: Concrete Grid Pavers (w/ Pea Gravel)
 Use: Park and beach parking

Size (stalls/sq. ft.): 8 stalls
 Approximate Drainage Area: Permeable Area
 Construction Date: 2001
 Address: 101 S. Lumina Ave., Wrightsville Beach, NC
 Test Date: July 23, 2003
 Visual Assessment: Some sand filled in voids, and negligible grass growth.
 Maintenance Practice: Once every two weeks with a street sweeper.
 (Tracy Dail, Wrightsville Beach)

Run #1	Run #2	Run #3	Average
5.19	3.28	5.12	4.53

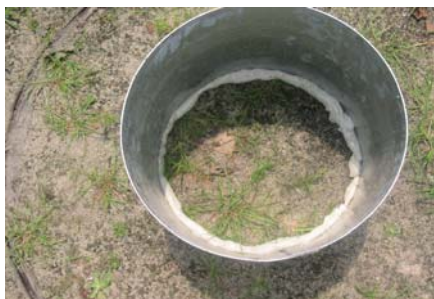
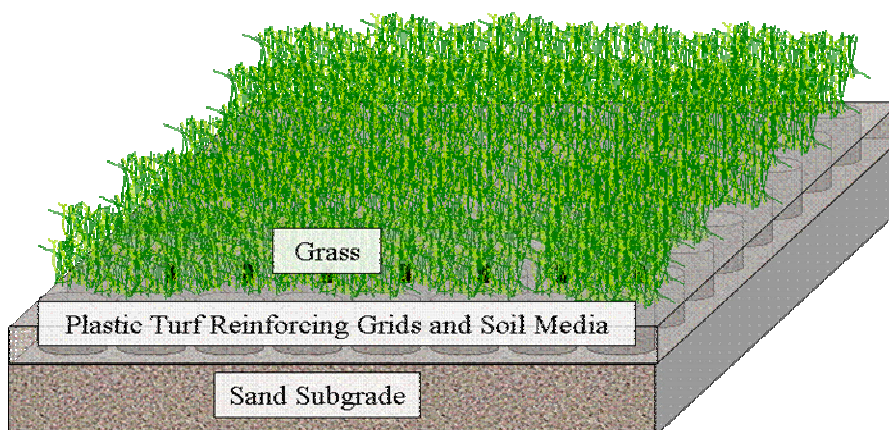
Appendix C25

Site 25: Kinston PTRG
 Type of Surface: Plastic Turf Reinforcing Grids
 Use: Police Vehicle Parking

Size (stalls/sq. ft.): 1900 sq. ft. 6 stalls
 Approximate Drainage Area: 1900 sq. ft.
 Construction Date: Summer 1999
 Address: 207 E. King St., Kinston, NC
 Test Date: July 21, 2003
 Visual Assessment: Some areas with no grass, but grass seems to do well.
 Maintenance Practice: Mowing when needed.

Bare Area (cfs/ac)			
Run #1	Run #2	Run #3	Average
3.08	2.09	5.68	3.62
Grassy Area (cfs/ac)			
Run #1	Run #2	Run #3	Average
10.96	13.46	12.75	12.39
